Test Report

SPONSOR: **ClarkDietrich**
West Chester, OH

Sound Transmission Loss
RAL™-TL21-030

ON: 8-Inch Concrete Slab with tiled carpet flooring, insulated single-layer gypsum board ceiling on ClarkDietrich Sound Clips™ (CDSC)

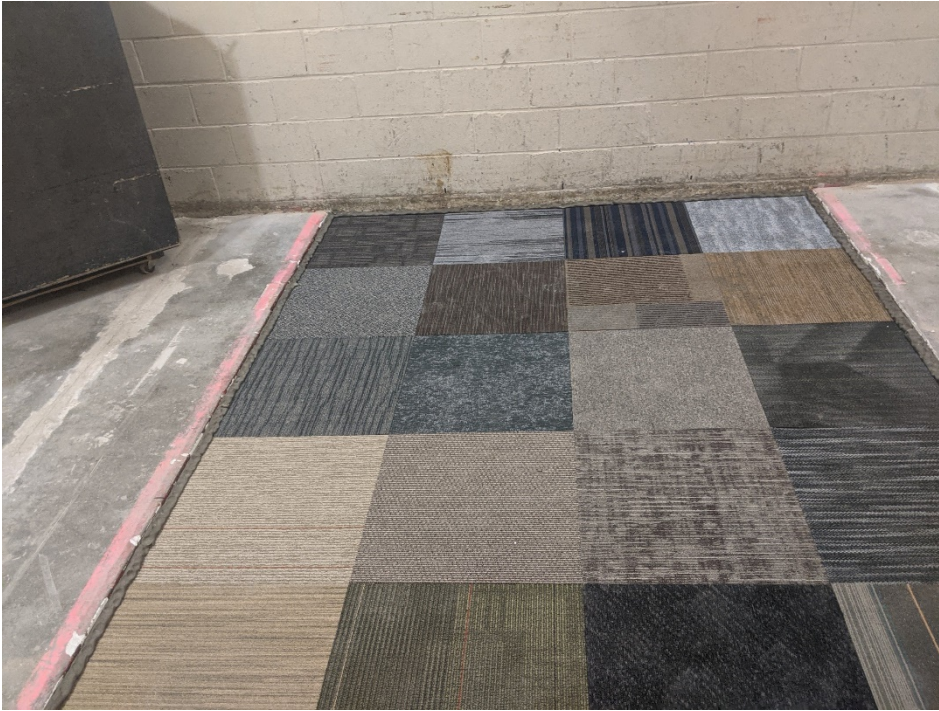
Figure 1 – Specimen mounted in test opening, as viewed from source room

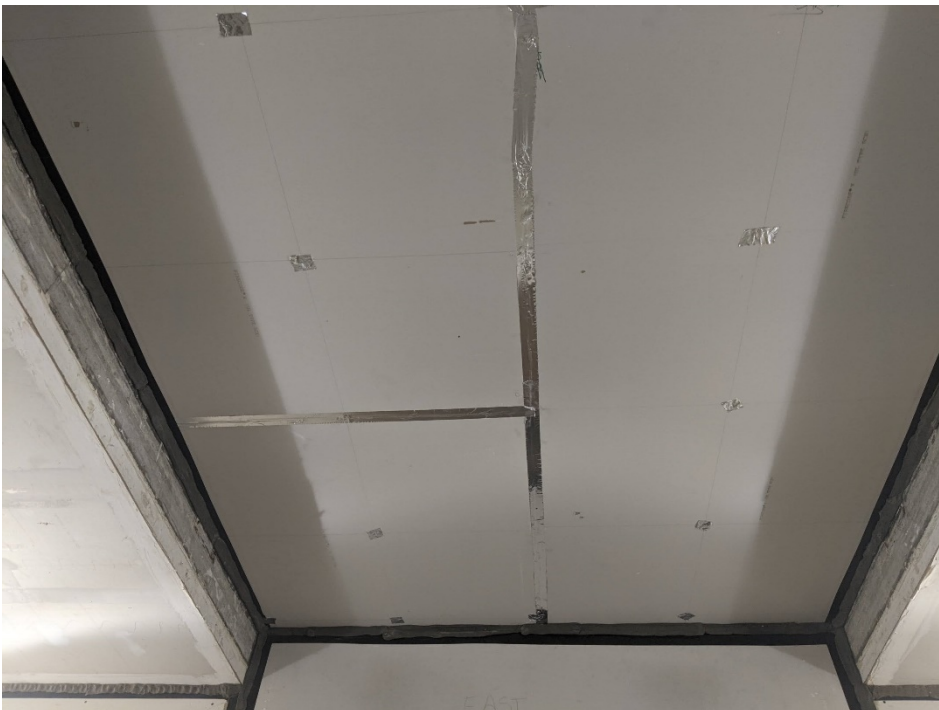
Figure 2 – Specimen mounted in test opening, as viewed from receive room

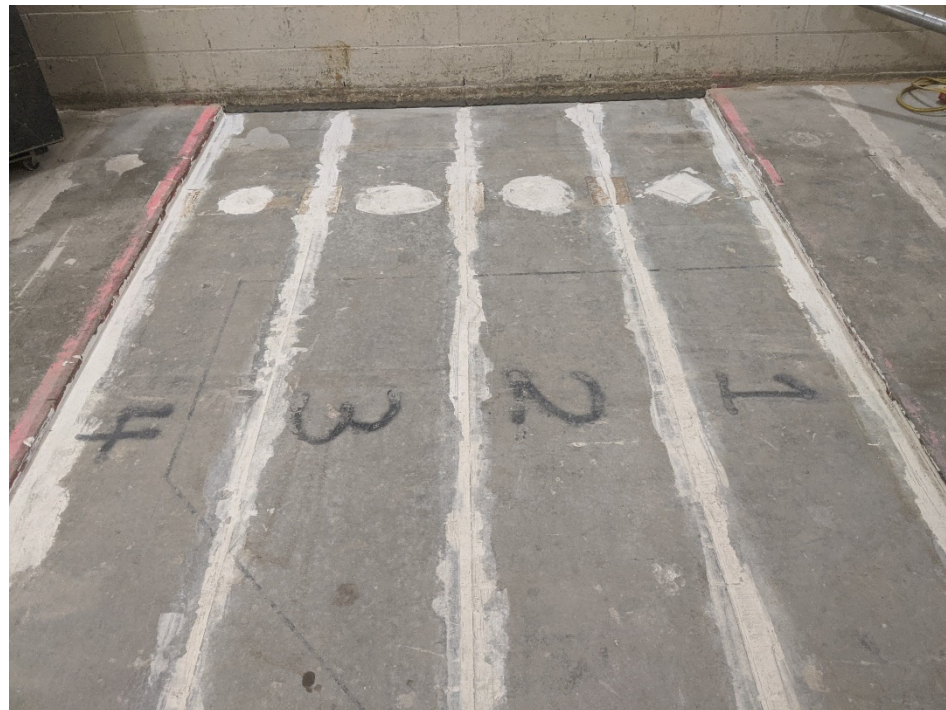
Figure 3 – Concrete slabs prior to installation of carpet flooring, viewed from source room

Material: Wire-reinforced concrete
Dimensions: 4 @ 610 mm (24 in.) x 4267 mm (168 in.)
Thickness: 203 mm (8 in.)
Overall Weight: 5023.08 kg (11074 lbs)
Mass per Unit Area: 482.75 kg/m² (98.875 lbs/ft²)
Installation: Laid in test opening over 152.4 mm (6 in.) wide knee walls constructed from isolated wood framing
Joint undersides sealed with acoustical caulk and tape
Top of joints filled with general purpose sand, sealed with premixed masonry joint compound

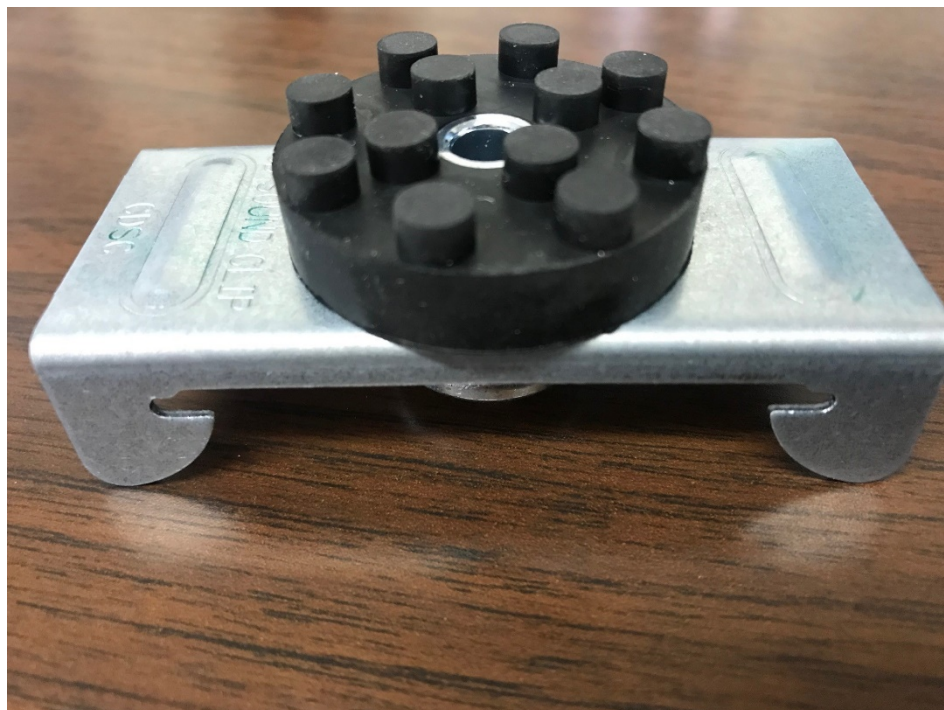
Figure 4 – Detail of isolating clip

Material: Metal, rubber (see Products Under Test)
Dimensions: 76 mm (3 in.) long by 35 mm (1.375 in.) wide
Thickness: 32 mm (1.25 in.)
Installation: Fastened through center to anchor holes in underside of concrete slabs
Staggered array, spaced 1219 mm (48 in.) on center, 16 pieces total
Overall Weight: 1.02 kg (2.25 lbs)

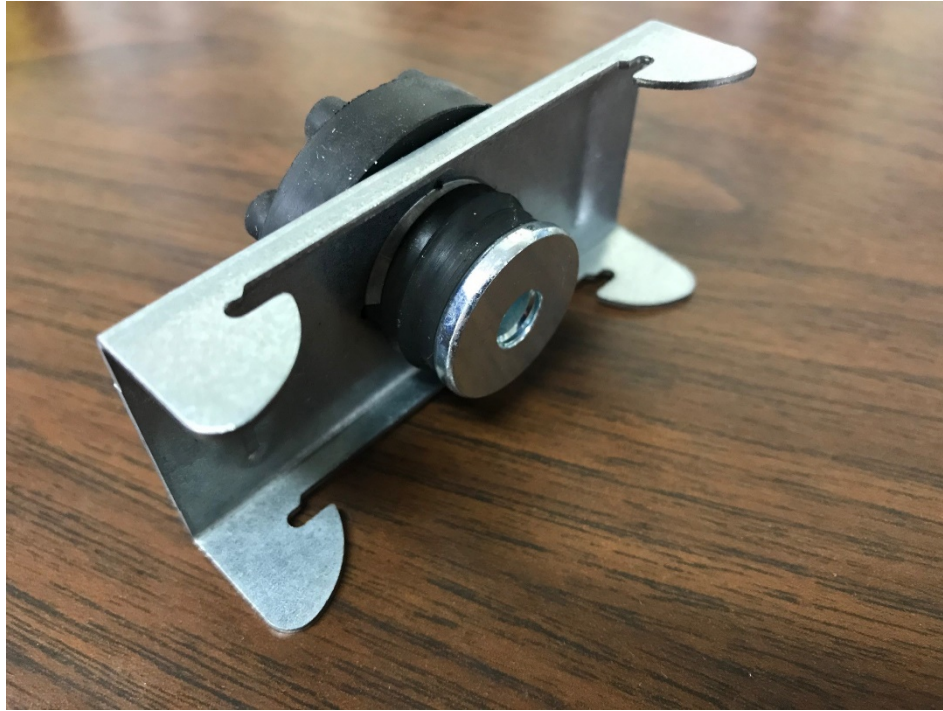
Figure 5 – Detail of isolating clip

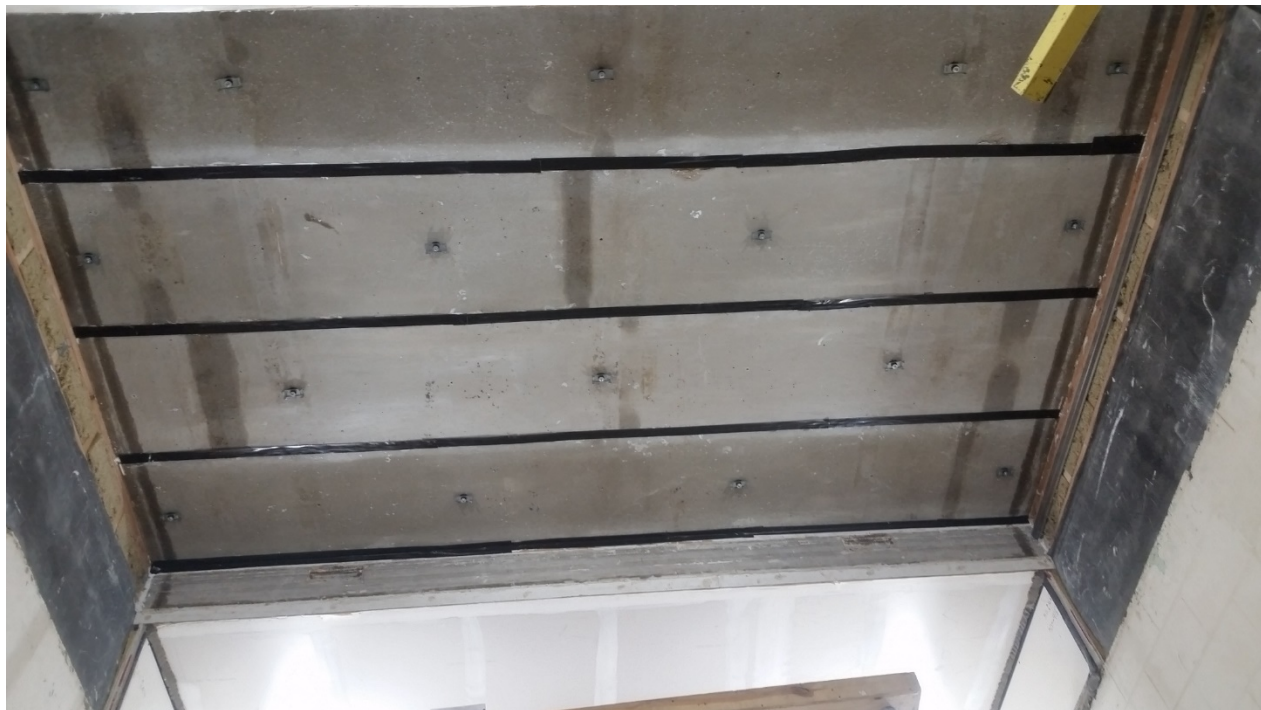
Figure 6 – Isolating clips installed to bottom of concrete slabs

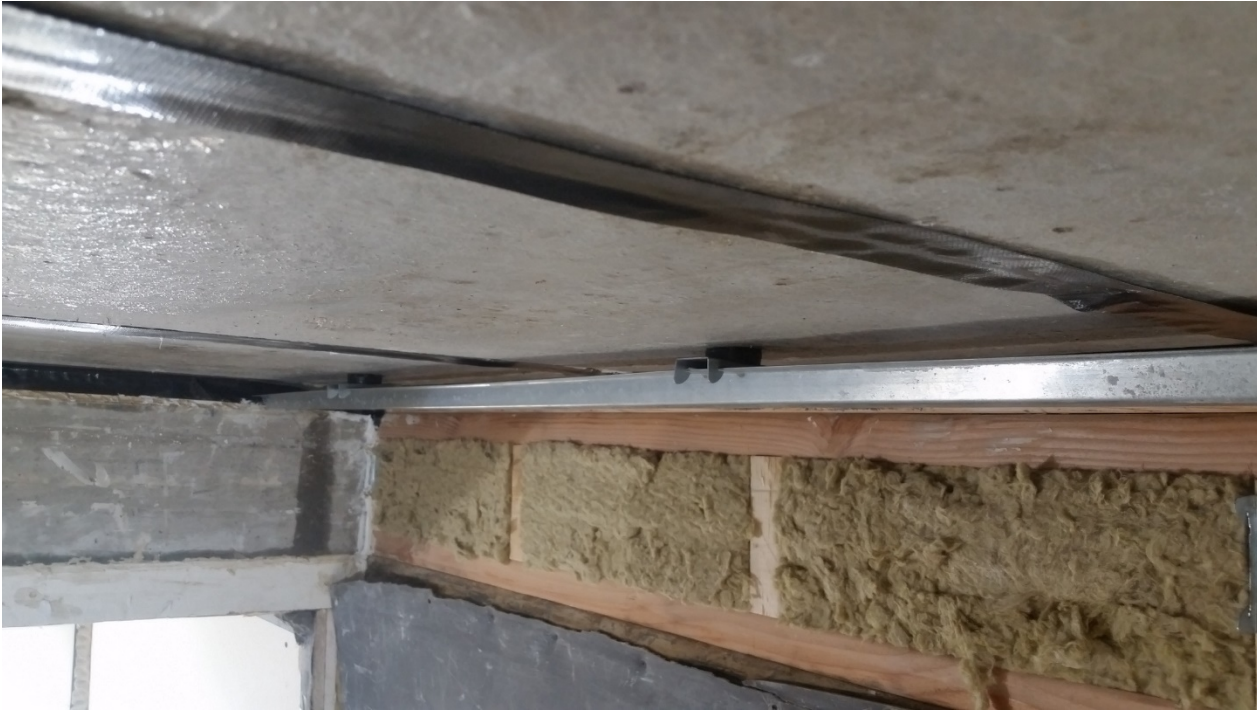
Figure 7 – Furring channel being installed to product under test

Material: Steel furring channel (see Products Under Test)
Dimensions: 7 @ 2463.8 mm (97 in.) long by 69 mm (2.72 in.) wide
Formed Depth: 22.2 mm (0.875 in.)
Steel Thickness: 0.49 mm (0.019 in.)
Installation: Clipped in to isolating clips, oriented perpendicular to concrete slab
Overall Weight: 6.58 kg (14.5 lbs)
Mass per Unit Length: 0.38 kg/m (0.26 lbs/ft)

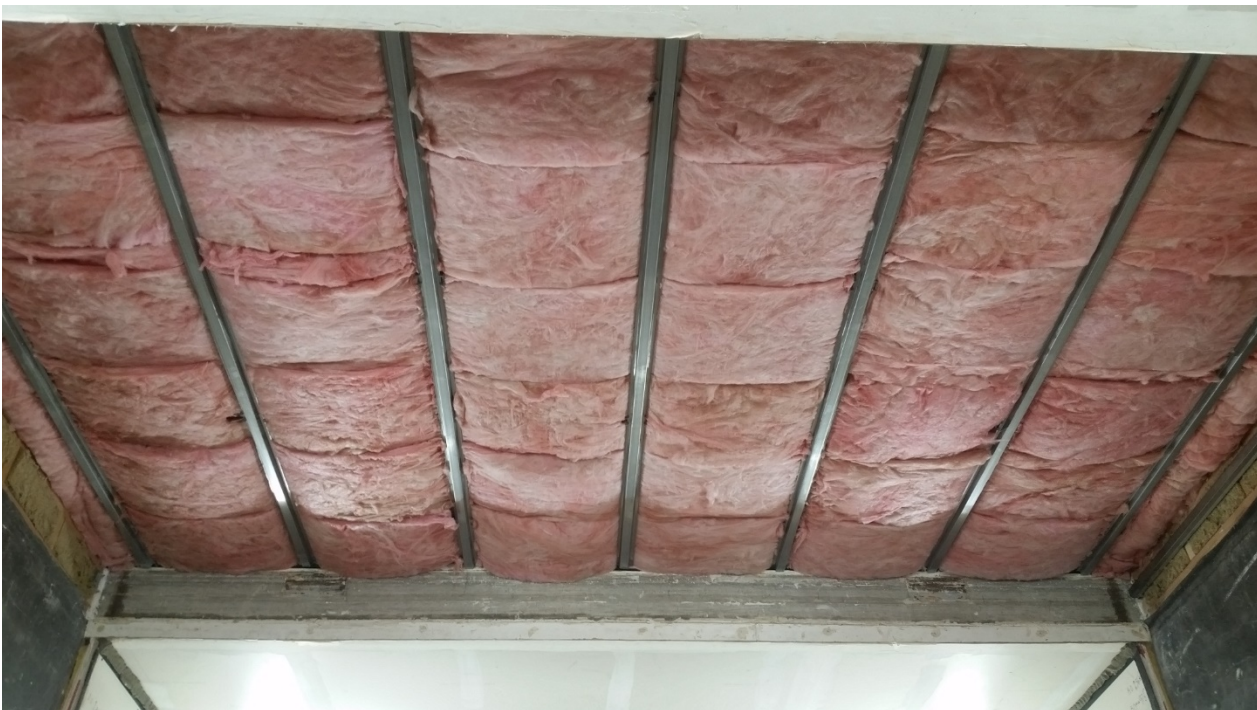
Figure 8 – Furring channel and insulation installed below slabs

Material: R-6.7 unfaced fiberglass insulation
Dimensions: 406 mm (16 in.) wide by 1219 mm (48 in.) long pieces
Thickness: 51 mm (2 in.)
Installation: Draped over furring channel
Orientation: Length of pieces perpendicular to furring channel
Overall Weight: 4.31 kg (9.5 lbs)
Density: 8.78 kg/m³ (0.55 lbs/ft³)

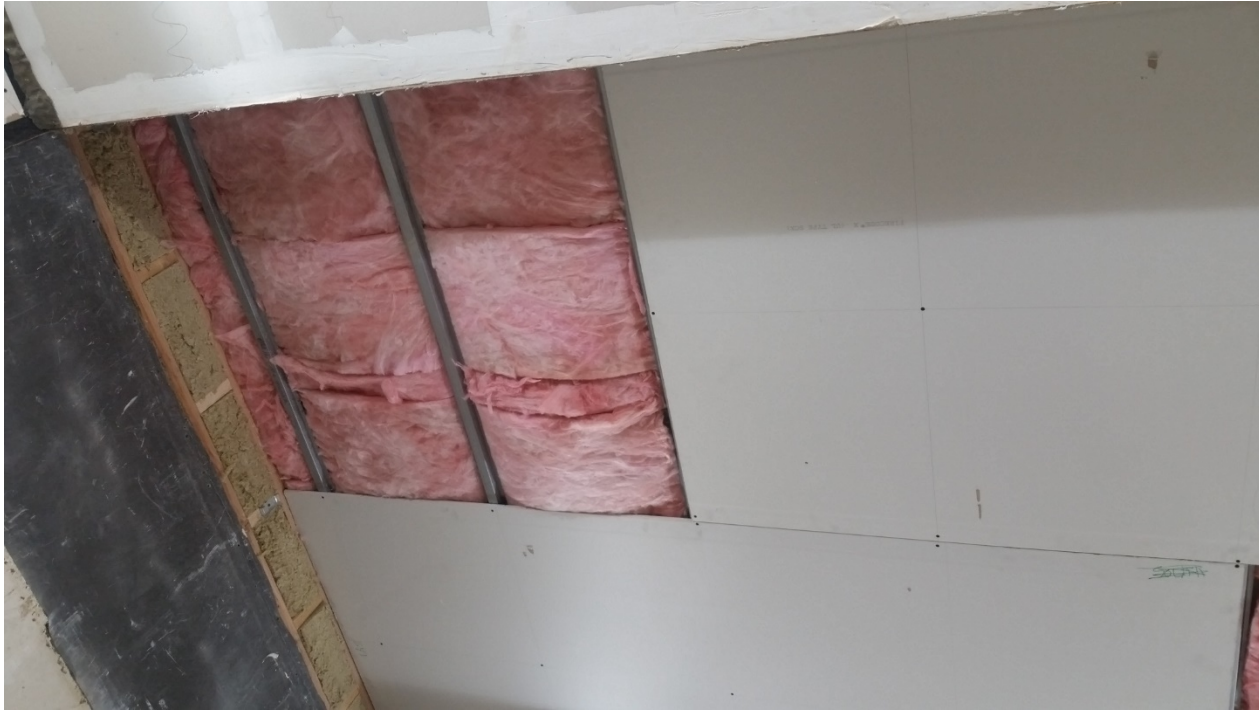
Figure 9 –Gypsum board partially installed to furring channel

Material: Type X gypsum board
Manufacturer: USG
Brand name: Sheetrock® brand, Firecode® core (type X)
Dimensions: 1219 mm (48 in.) wide by 2616 mm (103 in.) long
1219 mm (48 in.) wide by 2584.5 mm (101.75 in.) long
1219 mm (48 in.) wide by 1384 mm (54.5 in.) long
1219 mm (48 in.) wide by 1346 mm (53 in.) long
Thickness: 15.9 mm (0.625 in.)
Installation: Fastened to furring channel at center flange
Fasteners: Type S bugle head drywall screws @ 31.8 mm (1.25 in.)
Fastener Spacing: 610 mm (24 in.) on center
Overall Weight: 105.23 kg (232 lbs)
Mass per Unit Area: 10.88 kg/m² (2.23 lbs/ft²)

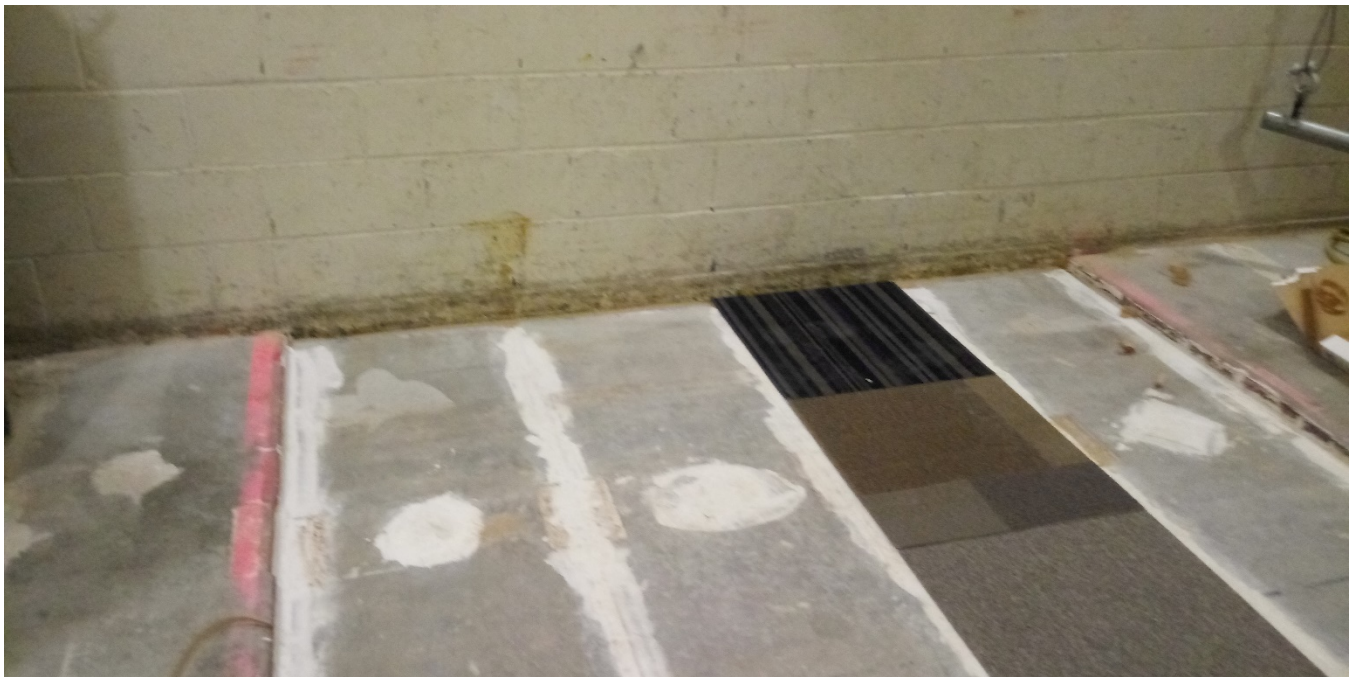
Figure 10 –Carpet flooring partially installed

Materials: Tufted carpet on semirigid polymer backer
Dimensions: 28 tiles @ 610 mm (24 in.) by 610 mm (24 in.)
Thickness: 6.35 mm (0.25 in.)
Installation: Adhered with integrated adhesive strips over concrete slab
Overall Weight: 32.09 kg (70.75 lbs)
Mass per Unit Area: 3.08 kg/m² (0.63 lbs/ft²)
