CLARKDIETRICH BUILDING SYSTEMS, LLC ACOUSTICAL PERFORMANCE TEST REPORT

SCOPE OF WORK ASTM E90 SOUND TRANSMISSION LOSS TESTING ON A UL-V438, WALL SYSTEM

REPORT NUMBER L3173.15-113-11-R0

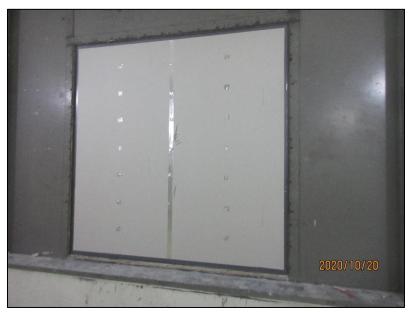
Photo No. 1 Receive Room View of Installed Specimen

SOURCE SIDE GYPSUM BOARD	Three Layers ½" Type C			
FURRING CHANNELS	25 Gauge (18 mil)			
STUD TREATMENT	ClarkDietrich Sound Clip (CDSC)			
STUDS	1-5/8" ProSTUD 25 (15 mil), 25-Gauge Equivalent Steel,			
	24" Centers			
TRACK	1-5/8" ProTRAK 25 (15 mil), 25-Gauge Equivalent Steel			
INSULATION	2-3/4" Fiberglass unfaced			
RECEIVE SIDE GYPSUM BOARD	Three Layers 1/2" Type C

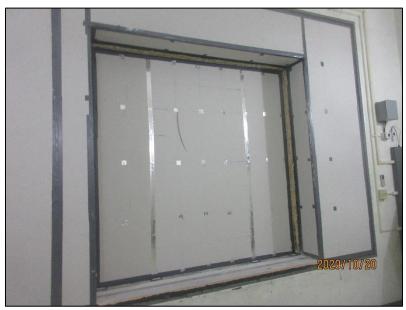
Photo No. 2 Source Room View of Installed Specimen
