# CLARKDIETRICH BUILDING SYSTEMS, LLC ACOUSTICAL PERFORMANCE TEST REPORT

ASTM E90 AND ASTM E492 TESTING ON CERAMIC TILE ON NOBLESEAL CIS

Open Web Truss - 406 mm (16") - ClarkDietrich<sup>®</sup> Sound Clip - One-Layer USG SHEETROCK<sup>®</sup> Brand FIRECODE<sup>®</sup> C Core

J4777.06-113-11-R1

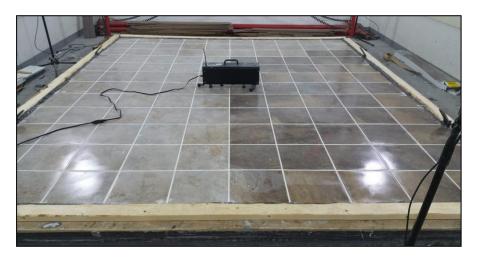
Photo No. 1 Source Room View of Test Specimen Installation

The full test specimen was assembled on the day of testing by B&C. All materials provided by the client were installed on an existing B&C assembly (Open Web Truss - 406 mm (16") - ClarkDietrich<sup>®</sup> Sound Clip - One-Layer USG SHEETROCK<sup>®</sup> Brand FIRECODE<sup>®</sup> C Core) utilizing B&C-supplied materials. The assembly was installed in a steel test frame which was installed into the opening between the source and receive rooms in the test chamber. The test frame was isolated from the structure with dense neoprene gasket.

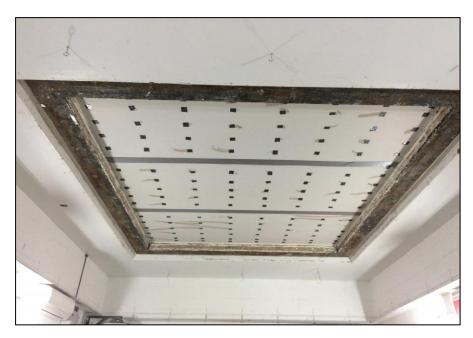
Photo No. 2 Receive Room View of Test Specimen Installation
