SOUND TRANSMISSION LOSS TEST REPORT NO. TL18-205

CLIENT: ClarkDietrich
9050 Centre Pointe Drive, #400
West Chester, Ohio 45069

DESCRIPTION OF TEST SPECIMEN

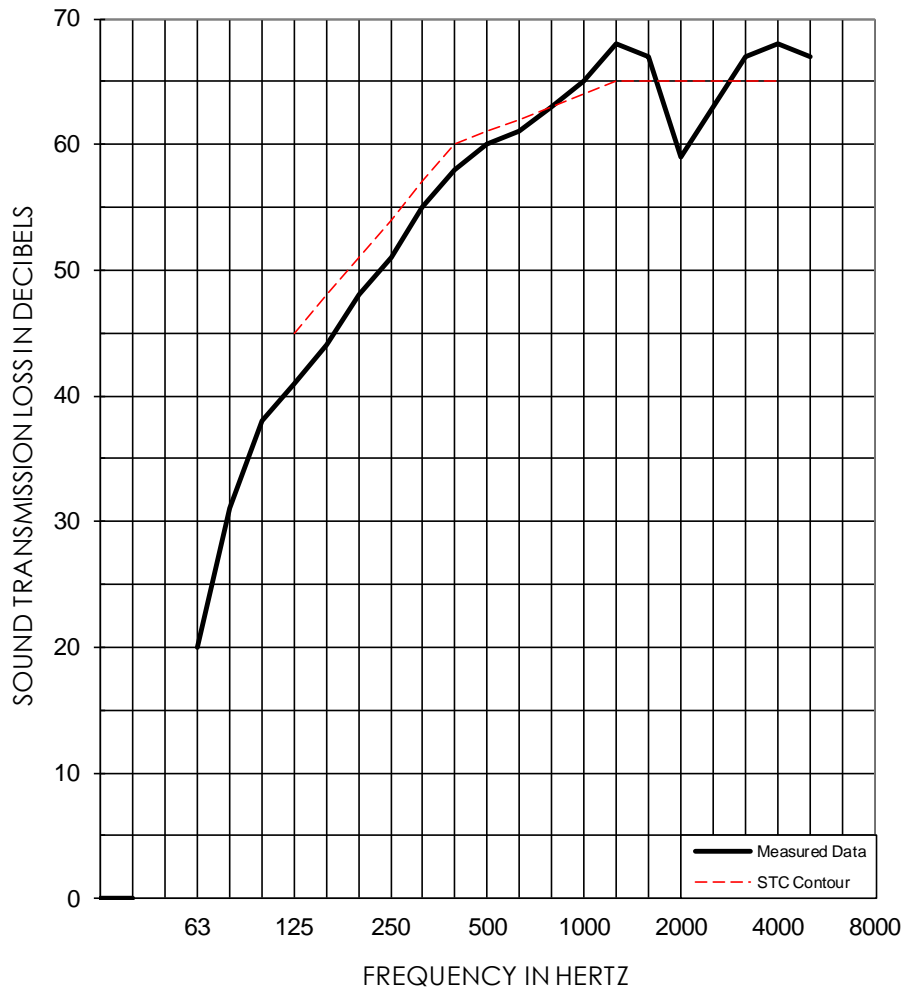
1/3 OCT BAND CNTR FREQ	63	80	100	125	160	200	250	315	400	500
TL in dB	20	31	38	41	44	48	51	55	58	60
95% Confidence in dB deficiencies	1.42	1.92	2.07	1.47	0.89	0.76	0.80	0.52	0.36	0.38
				(4)	(4)	(3)	(3)	(2)	(2)	(1)
1/3 OCT BAND CNTR FREQ	630	800	1000	1250	1600	2000	2500	3150	4000	5000
TL in dB	61	63	65	68	67	59	63	67	68	67
95% Confidence in dB deficiencies	0.29	0.44	0.38	0.39	0.36	0.56	0.55	0.31	0.32	0.50
	(1)	(0)				(6)	(2)

EWR	OITC	Test Date: 02 March 2018	STC
61	48	Specimen Area: 64 sq.ft.	61
		Temperature: 66.7 deg. F	(28)
		Relative Humidity: 52 %

One-third octave band sound transmission loss values are plotted and tabulated on the attached sheet. ASTM minimum volume requirements are met at 80 Hz and above. The Outdoor-Indoor Transmission Class rating determined in accordance with ASTM E 1332-10a was OITC-48. The Sound Transmission Class rating determined in accordance with ASTM E 413-10 was STC-61.

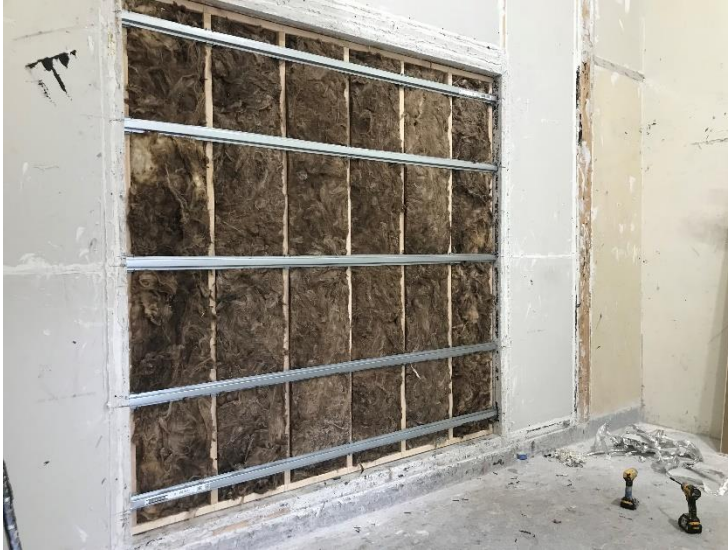
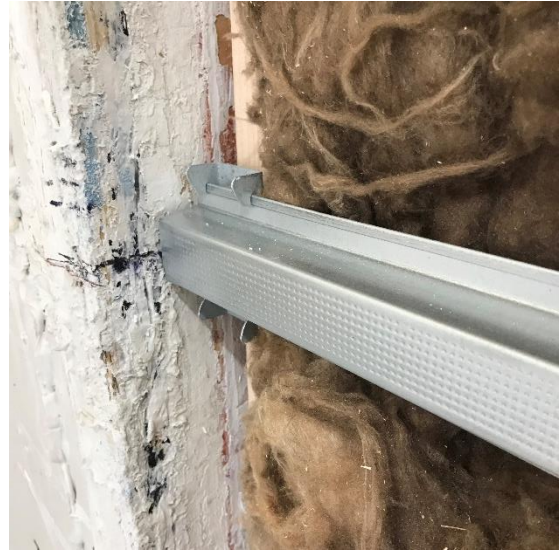
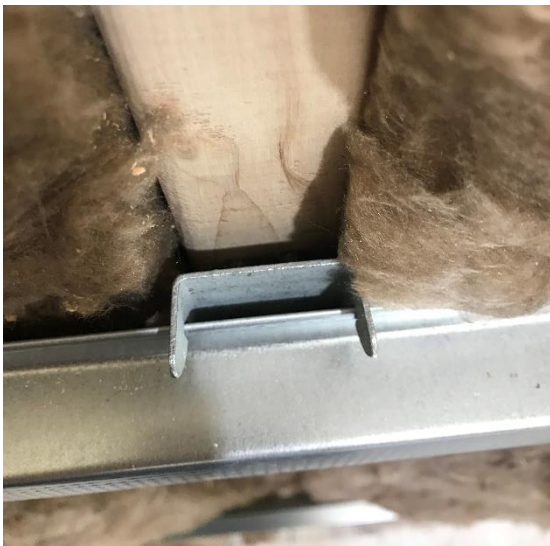
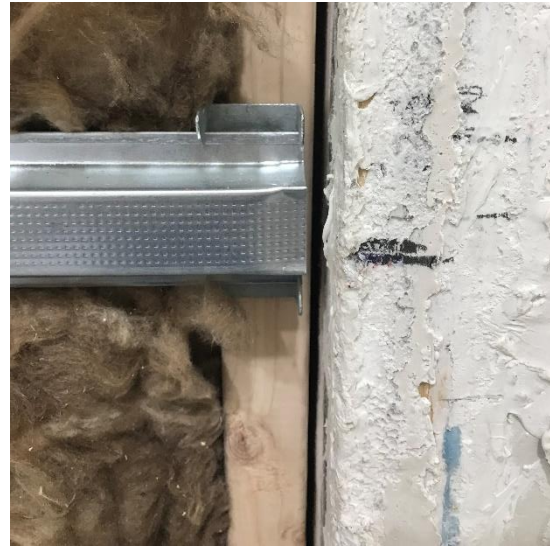
PHOTOGRAPHS OF TEST SPECIMEN

The test specimen was a single stud wall assembly constructed from 38 mm by 89 mm (1-1/2 inch by 3-1/2 inch) wood studs, Johns Manville R-19 unfaced fiberglass insulation in the stud cavities, ClarkDietrich Acoustical Clips with 22 mm (7/8 inch) ClarkDietrich 25-gauge hat channel, and USG Sheetrock® Brand Firecode® Type 'X' gypsum board.
